CASE NO. 4:14-cv-00045-A

**DEFENDANTS' APPENDIX IN SUPPORT OF DEFENDANTS' MOTION
TO EXCLUDE THE TESTIMONY OF MICHAEL MCCORT AND BRIEF IN SUPPORT**

Investigation of the Fire in the Matter of Sims vs. Kia

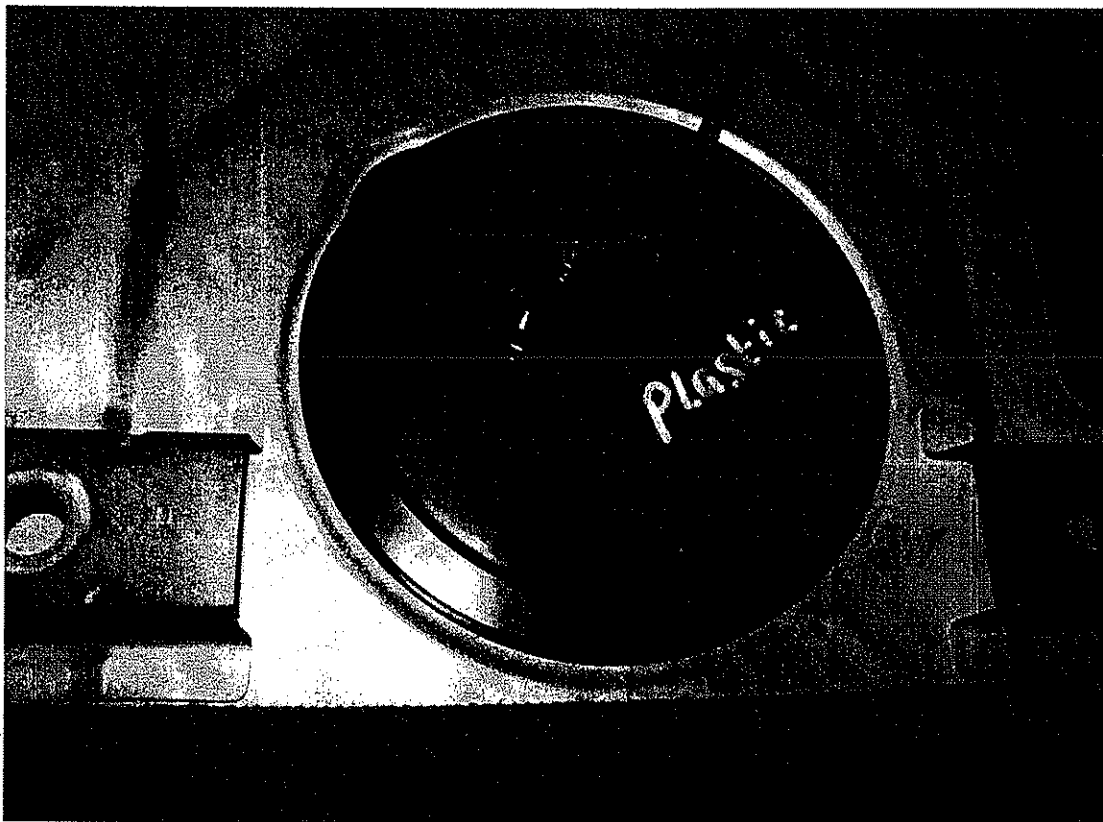
37. The service cover for the fuel pump is plastic and is located underneath the rear seat cushion as shown in the following photographs taken of a Defective Soul:

38. Thus, the only thing separating the rear passenger from these plastic fuel pump service covers is the seat cushion on which the passenger sits.

39. This is a highly dangerous location for a fuel pump service cover made of plastic, particularly given the other gas tank defects itemized above that already make the gas tank unreasonably dangerous. This location, coupled with the use of a plastic instead of a metal fuel pump service cover that is screwed to the floor pan of the vehicle, increases the likelihood that fire will penetrate the rear cabin in a "blow-torch" effect following a collision.

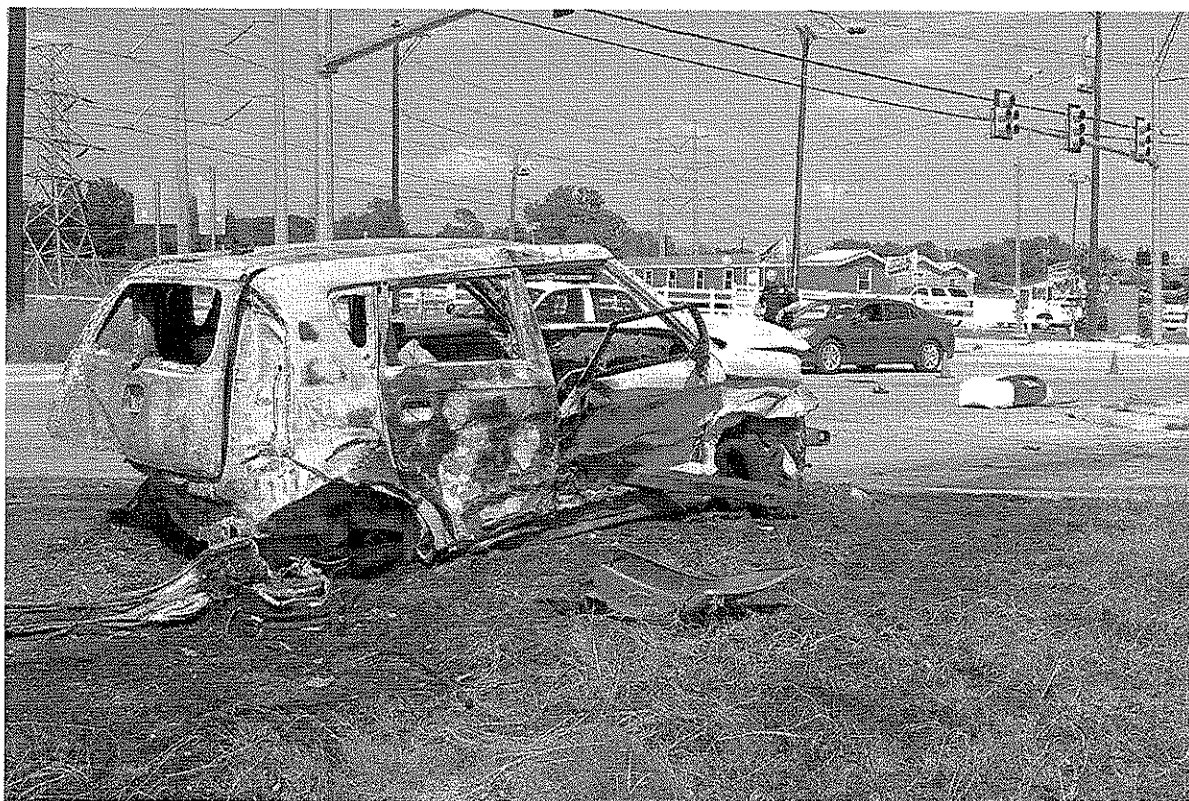
Figure 1 Kia Soul at the fire scene with the intersection where the collision took place in the background.

After the Kia Soul came to rest, the driver, Beverly Fuller, noticed smoke immediately². When she opened the door, flames were coming up from underneath the vehicle causing a “singe” sensation and she quickly closed the door.³ She then pushed the door open with her left leg and jumped across the flames to get out of the vehicle.⁴ After she exited the vehicle, she observed flames coming up and around the vehicle.⁵ The front passenger, Alonda Harper, observed “fire all around the car” when the vehicle came to rest.⁶ She also exited the vehicle through the driver’s side front door and described flames outside the door and “jumping” through them.⁷

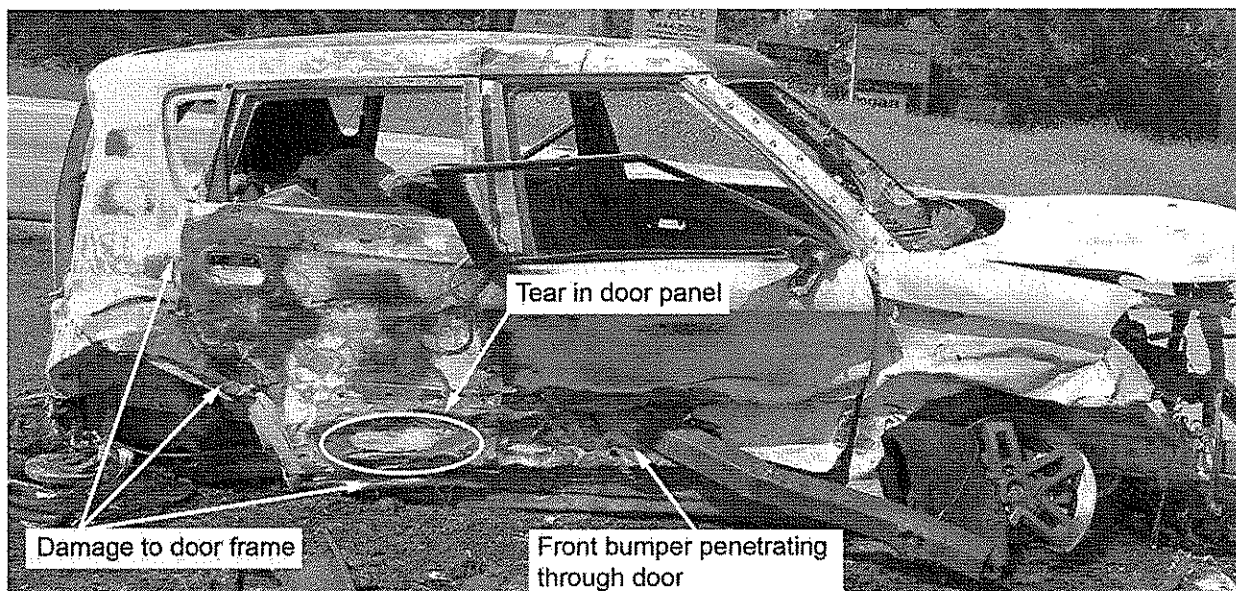
2. There were numerous, possible, collision-induced paths for fire spread into the interior.
 - a. An overview of the collision-induced damage to the passenger's side of the Kia Soul is shown in Figure 2. This damage was primarily due to the collision with the front portion of the Honda Odyssey. For reference, the passenger side of an undamaged, exemplar Kia Soul is shown in Figure 3.

Figure 2 Overview of collision damage to passenger's side of the vehicle.

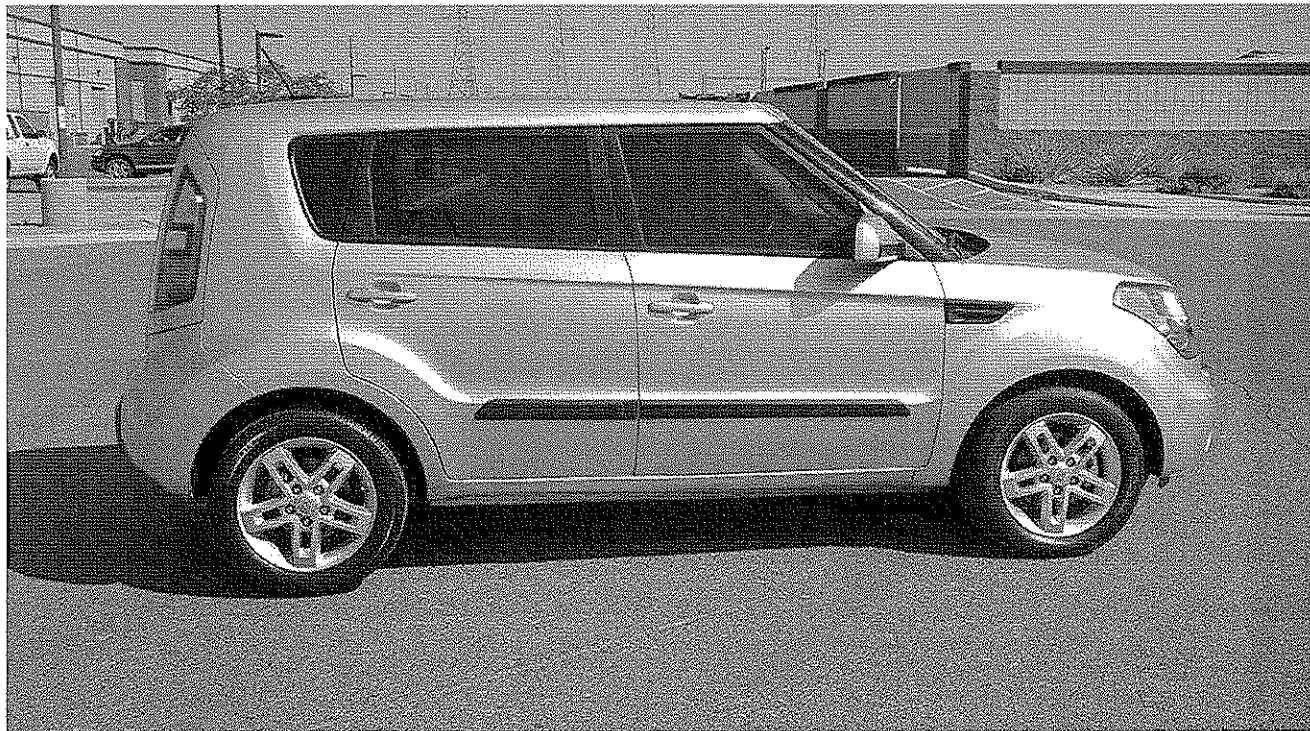
Figure 3 Passenger's side of an exemplar Kia Soul.

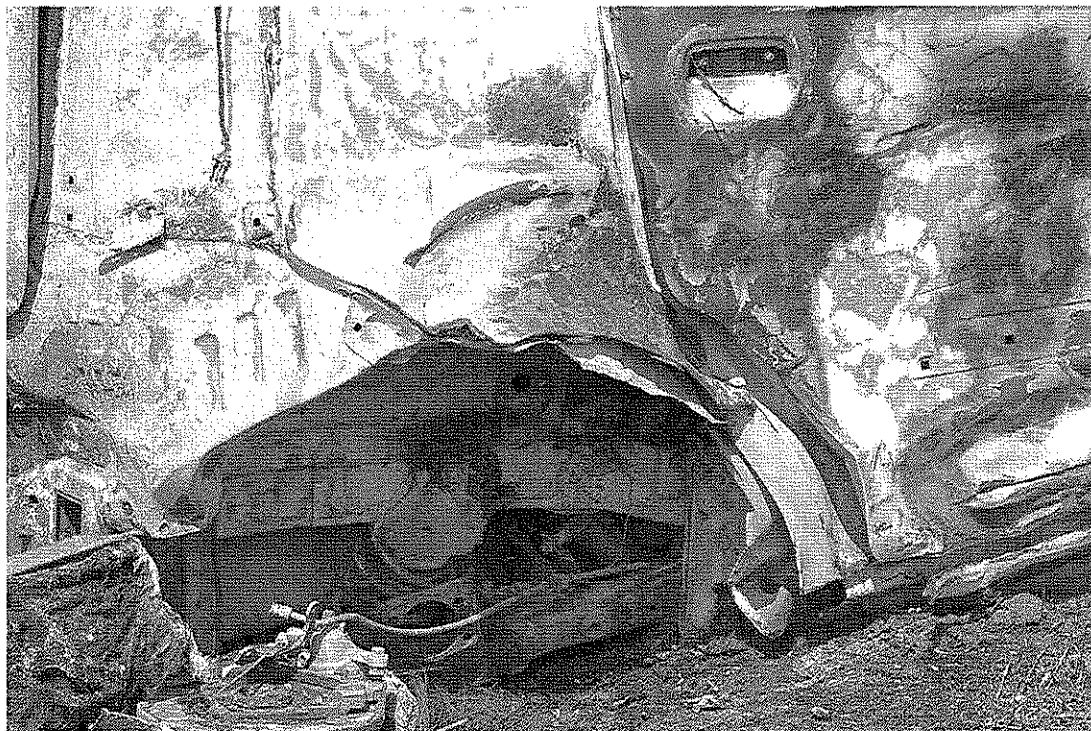
- ii. The collision with the Honda Odyssey also damaged the rear passenger door as shown in Figure 2 and Figure 4. This damage also provided possible paths for fire spread into the interior.

Figure 4 Close-up view of damage to the passenger's side rear door.

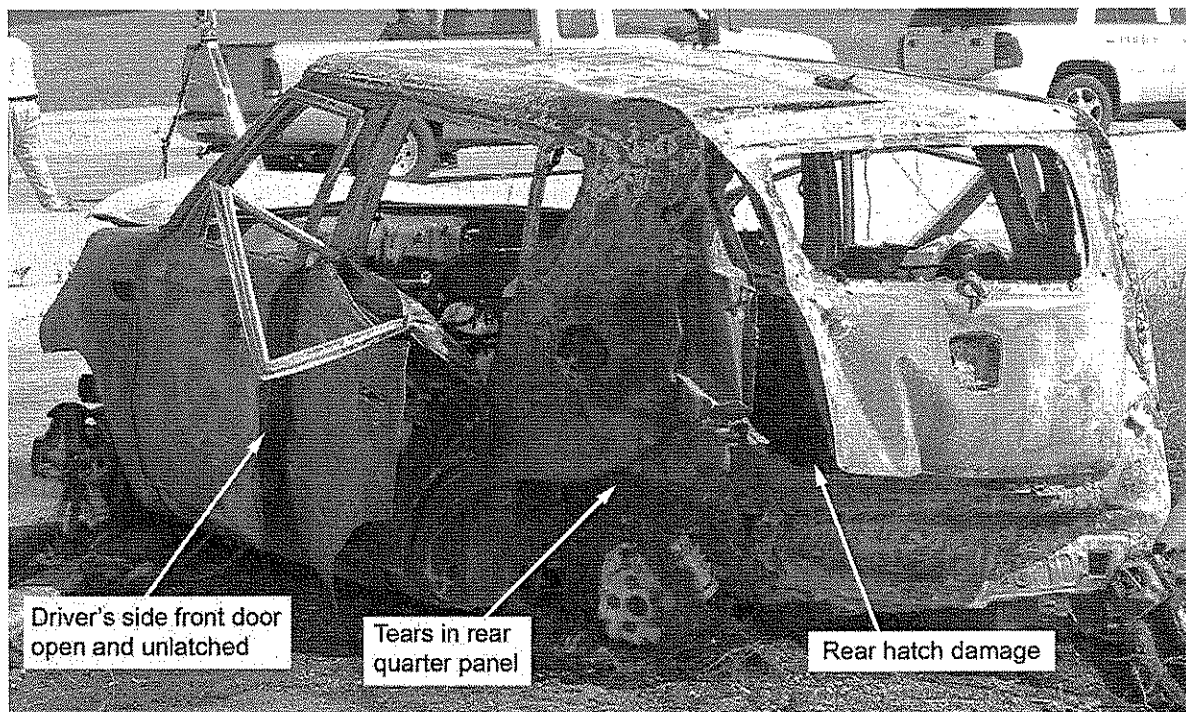
- b. An overview of damage sustained to the driver's side of the Kia Soul is shown in Figure 5. For reference, a similar view of an undamaged exemplar vehicle is shown in Figure 6.

- i. The collision with the light pole caused damage to the rear hatch, as shown in Figure 5. This damage provided a possible path for fire spread into the interior.

Figure 5 Overview of collision damage to the driver's side and the partially open driver's front door.

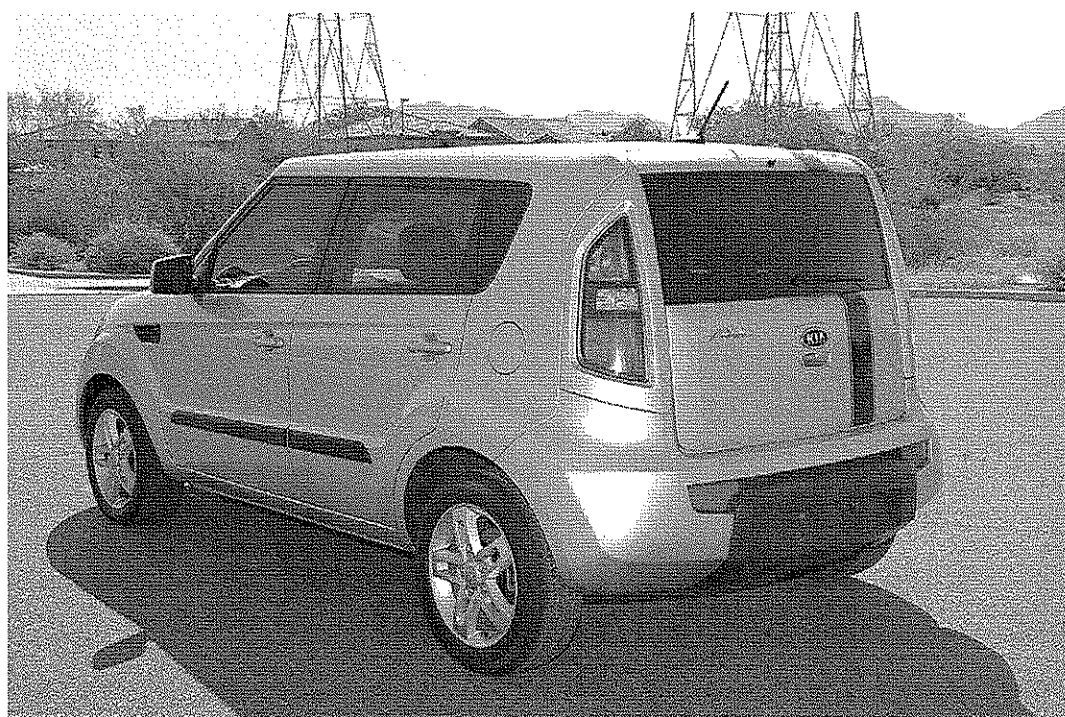
Figure 6 Driver's side rear quarter panel of an exemplar Kia Soul.

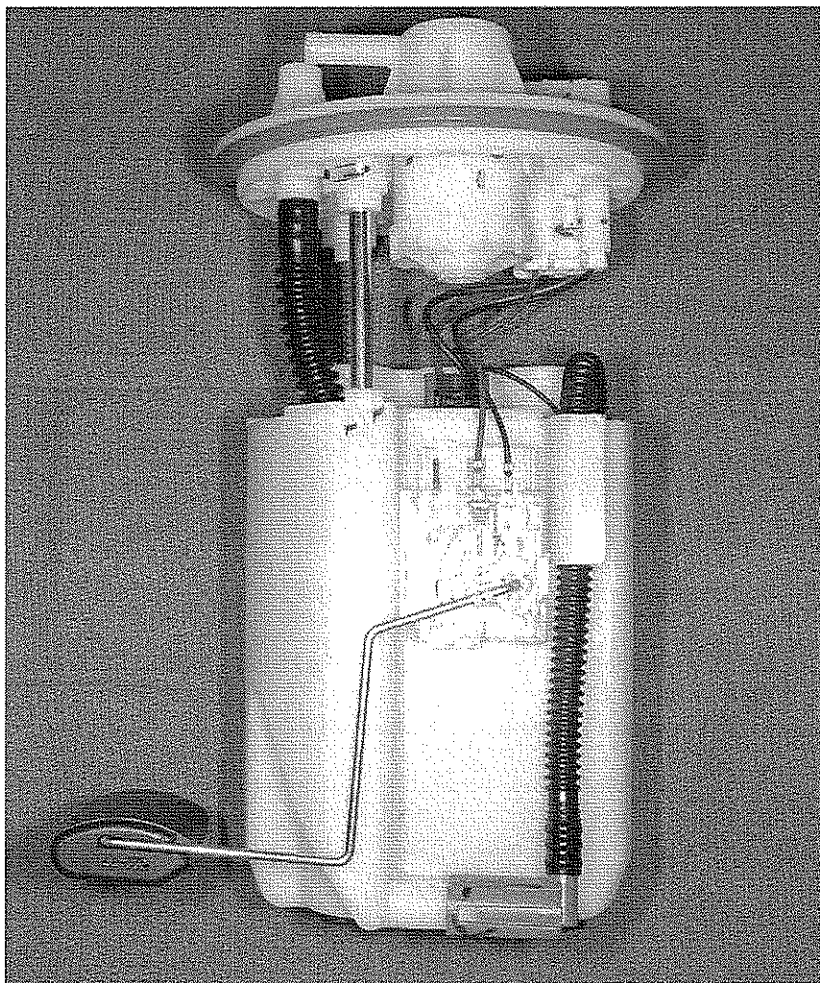
Figure 8 Exemplar sending unit located within the fuel tank.

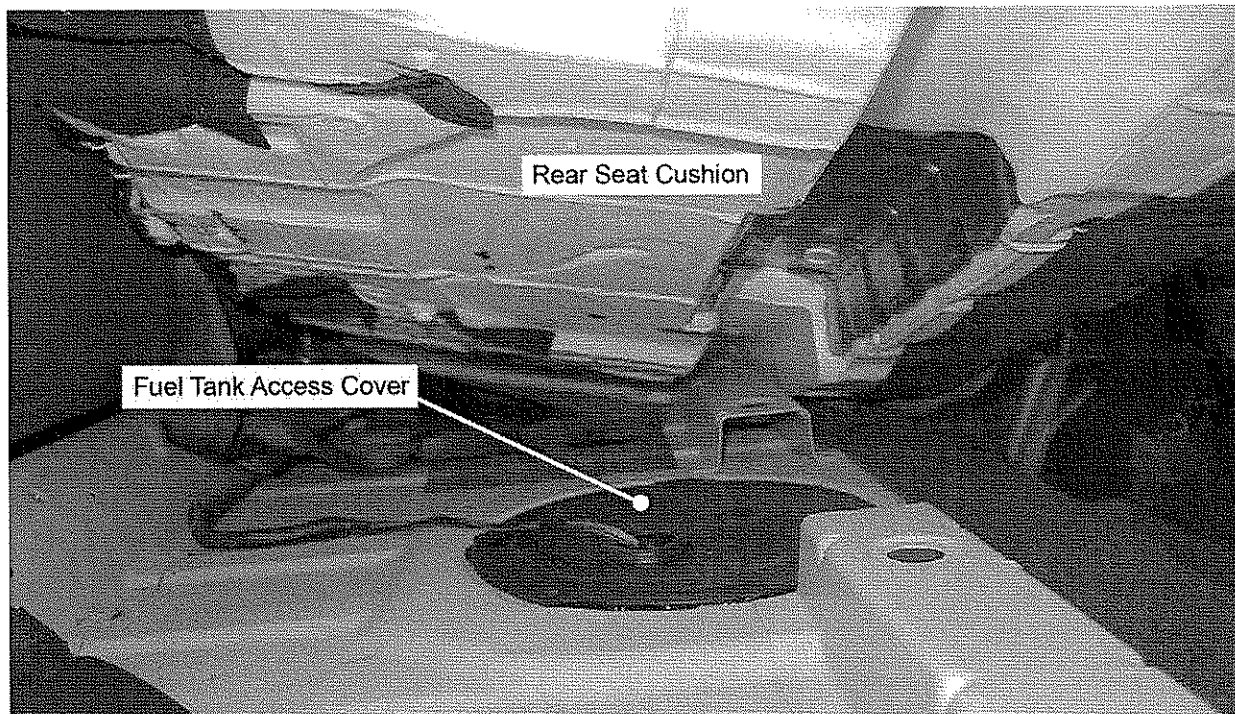
- b. While numerous, direct paths are available for fire spread into the interior, the path through the fuel tank access port involves numerous barriers. These barriers include the top of the sending unit, shown in Figure 8, the fuel tank access port cover and the rear seat cushion, as shown in Figure 9.
- i. As described in Opinion 4 and Opinion 5 below, the top portion of the sending unit likely survived the collision intact such that it acted as a barrier to fire spread.

Figure 9 Fuel tank access cover and rear seat cushion in an exemplar vehicle.

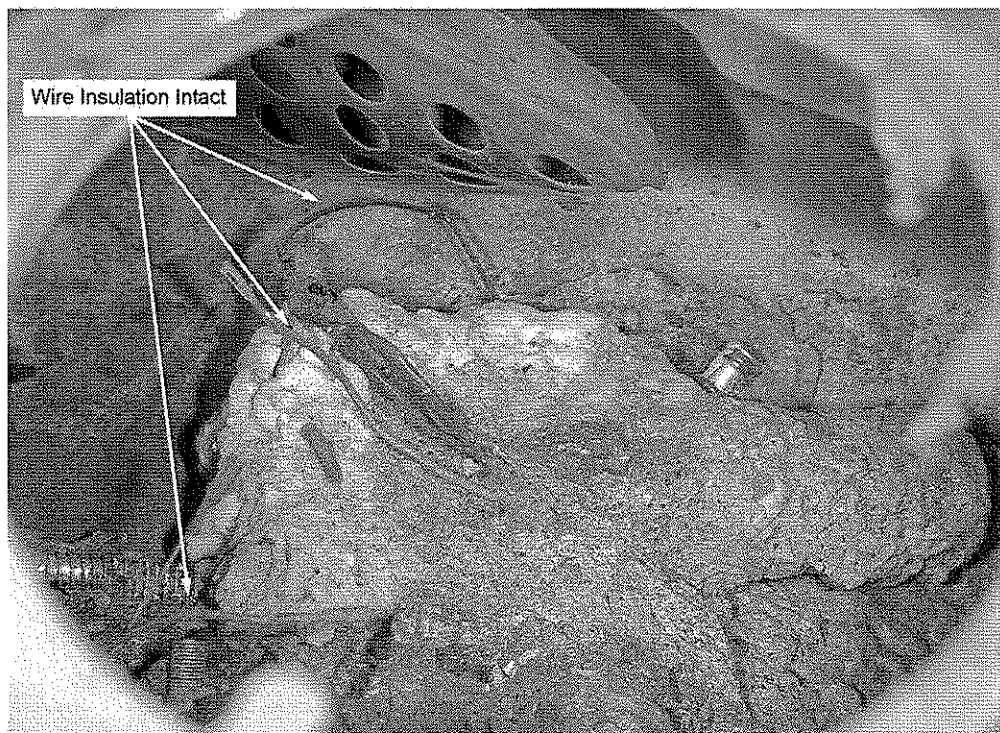
2. Had the fire penetrated the fuel tank access cover early in the fire, as Mr. Wallingford has opined, it would have also penetrated the top of the sending unit which is located in very close proximity to the fuel tank access cover. However, the vehicle burn patterns do not support this fire spread scenario.
 - a. The sending unit within the fuel tank suffered relatively little burn damage. As shown in Figure 10, the plastic portions of the sending unit were not consumed by the fire and numerous wires still have intact insulation present. In fact, the sending unit suffered less burn damage than any other component on the vehicle. The location of the sending unit within the subject fuel tank is shown in Figure 11.

Figure 10 Remains of the sending unit within the fuel tank.

3. The minimal thermal damage to the sending unit is likely the result of little, direct radiation exchange between the underbody fire and the sending unit.

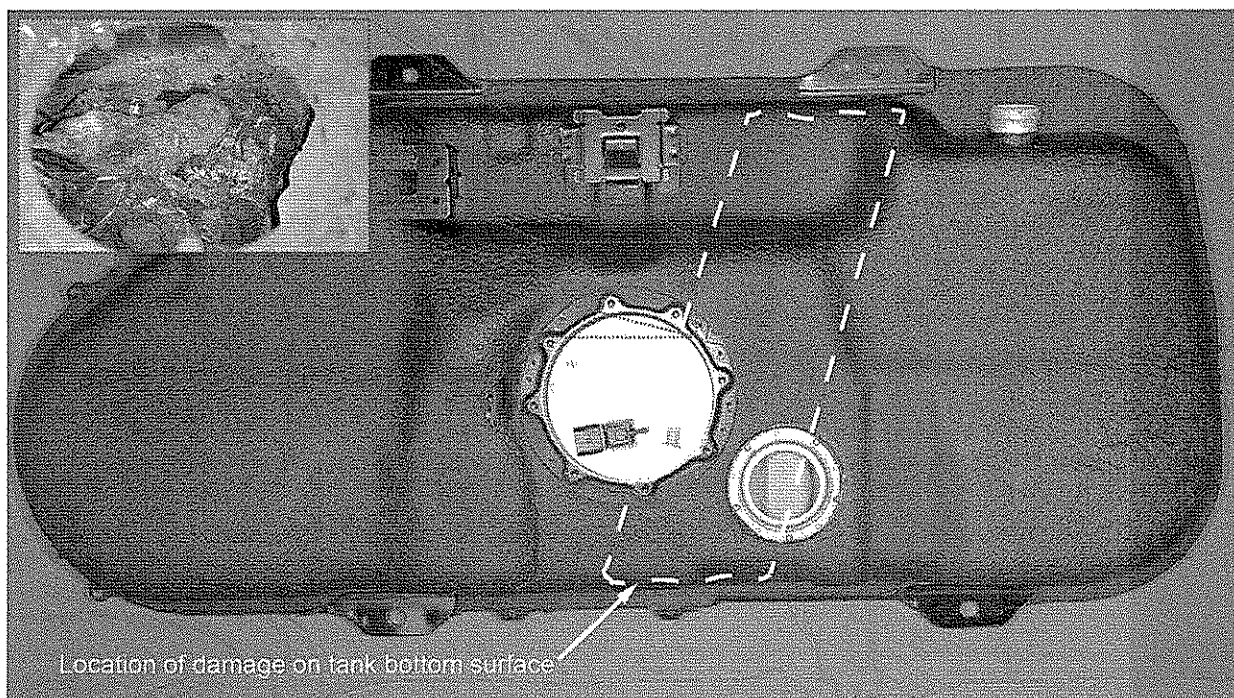
Figure 11 Top view of an exemplar fuel tank with the location of the subject sending unit remains superimposed on top.

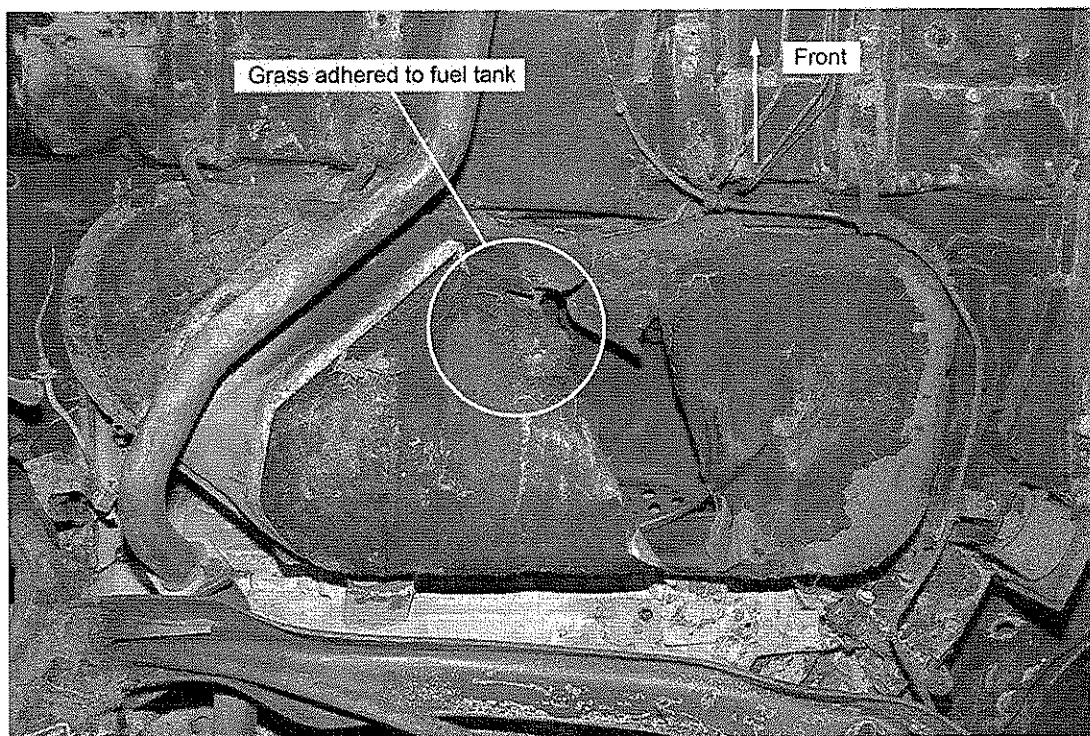
Figure 12 Location of grass adhered to the bottom of the fuel tank.

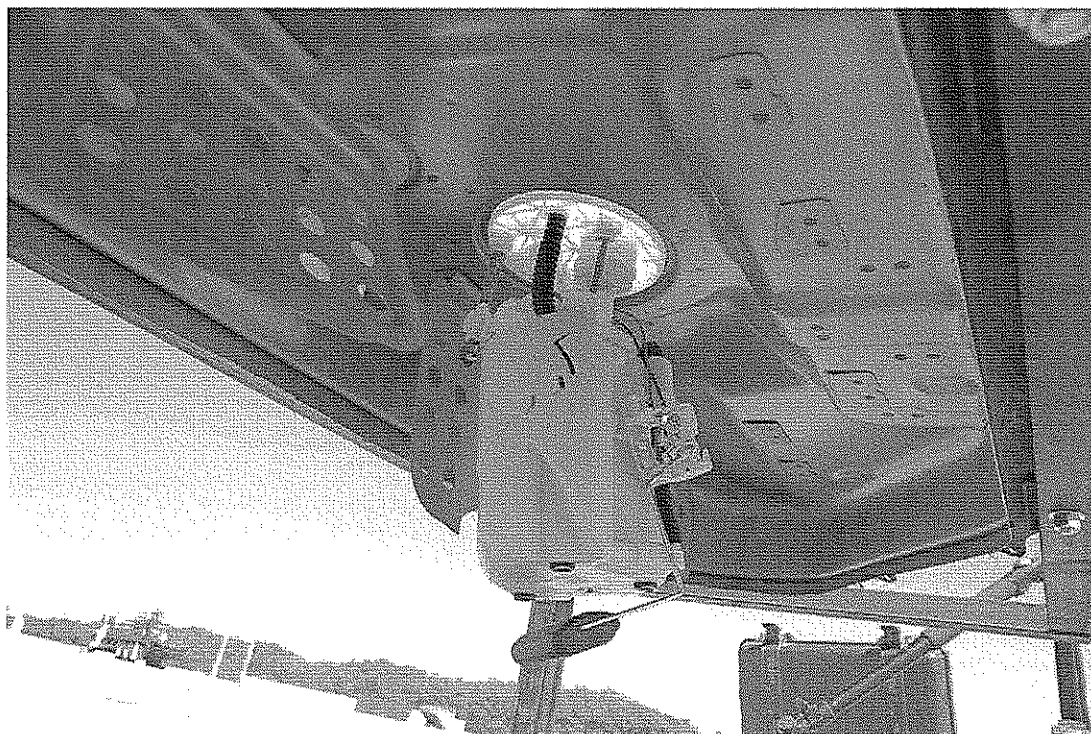
- c. Results of the testing illustrated that while the lower part of the sending unit was cracked, it remained in place, as shown in Figure 13. Furthermore, the top portion of the sending unit remained attached to the tank and would have acted as a barrier to fire spread.
- d. Additional testing conducted by Exponent on a shielded fuel tank on February 25, 2015 produced similar results. When an exemplar sending unit mounted in a shielded fuel tank contacted a pipe flange under circumstances similar to that in the subject incident, the top portion of the sending unit remained attached to the tank and would have acted as a barrier to fire spread. Additionally, the lower part of the sending unit also remained within the fuel tank.²¹

Figure 13 Post-test photograph of damage to sending unit after contact with the pipe flange – from Exponent September 26, 2014 testing.

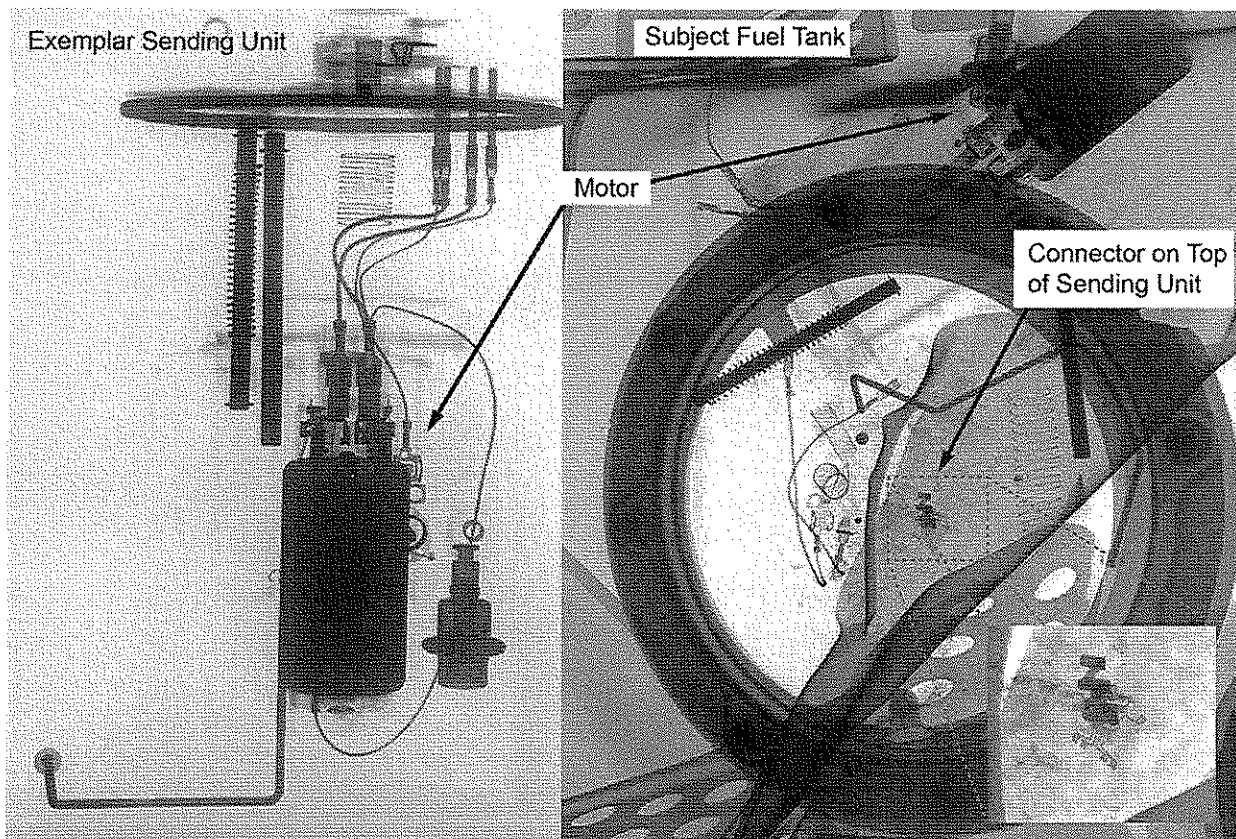
5. X-ray images of the subject fuel tank show that components of both the upper and lower portions of the sending unit were in the fuel tank at the time of the fire.
 - a. A comparison of X-ray images of an exemplar sending unit and the subject fuel tank illustrates that components from both the lower and upper part of the sending unit are present in the melted plastic remains of the fuel tank.
 - i. As shown in Figure 14, the sending unit motor is clearly visible in the subject fuel tank.
 - b. Also shown in Figure 14 is a connector from the top portion of the sending unit. Figure 15 shows both a photograph and an X-ray image of this connector. Also shown in Figure 15 is the connector from the subject fuel tank.
 - c. The location of the connector from the top portion on the sending unit in the fuel tank is consistent with it dropping into the fuel tank during the course of the fire.

Figure 14 Comparison of X-ray images from an exemplar sending unit (left) and the subject fuel tank (right).

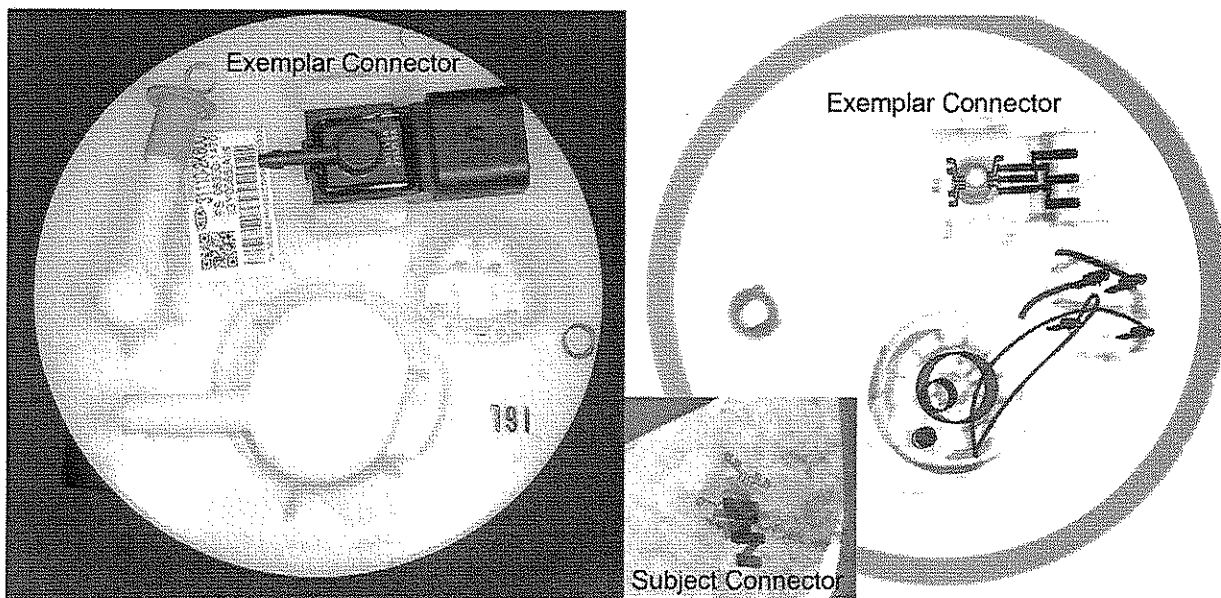
Figure 15 Comparison of a photograph of the top of the sending unit (left) with an X-ray image of the top of the sending unit (right) to the connector found in the subject fuel tank, see Figure 14.
